# Job Reference

Lorca Reservoir,  
Cartagena, Spain

## Project Description:

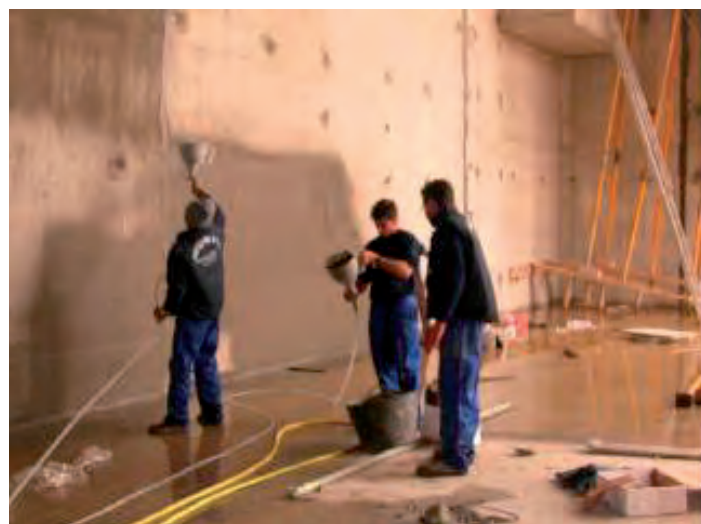
During the construction of Lorca Reservoir in 2004, an important element was the standardisation of joints to achieve maximum waterproofing. BASF elastomeric waterproof sealant MASTERFLEX® 474, was able to accommodate structural movement where applied to expansion joints and covered with EMACO® S88C Thixotropic repair mortar. After cleaning joints and ensuring the absence of moisture, backer rods were installed to support polyurethane sealant MASTERFLEX® 474, a product suitable for permanent submersion and fully tested for water migration. After the sealant had cured, a layer of MASTERSEAL® 550 polymer-modified waterproof coating was applied to fibreglass mesh placed over the joint to completely cover it. Once hardened, a second layer of MASTERSEAL® 550 was applied onto the reinforcement netting. To smooth out 90° angles and ensure continuity of waterproofing, floor/wall joints were coated with waterproof coating EMACO® S88C Thixotropic repair mortar. MASTERSEAL® 531, a single component waterproof coating suitable for contact with potable water, was spray applied to the internal walls of the reservoir for faster, more uniform application.
